Duncan Lake Intercounty Drain

Engineering Report

Duncan Lake Intercounty Drain Drainage Board

September 22, 2022

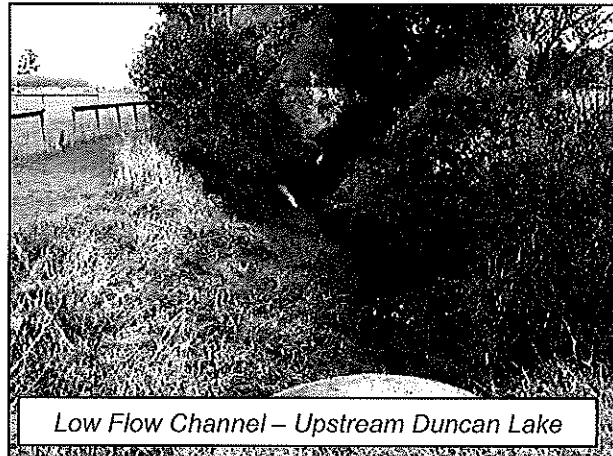
Low Flow Channel – Upstream Duncan Lake

The Drain is relatively flat from 108th Street to Duncan Lake with approximately 1-foot of sediment buildup in the channel bottom near 108th Street. The downstream invert elevation of the 108th Street 154" x 100" CMP arch culvert (763.8-ft NAVD 88) is essentially the same as the upstream invert elevation of the Noffke Drive 138" x 96" CMP arch culvert (763.52-ft NAVD 88). As a result backwater from Duncan Lake during storm events creates a tailwater effect on the culvert at 108th Street. The low point in the 108th Street is located approximately 300-ft west of the Drain and has an elevation of 770.26-ft NAVD 88.

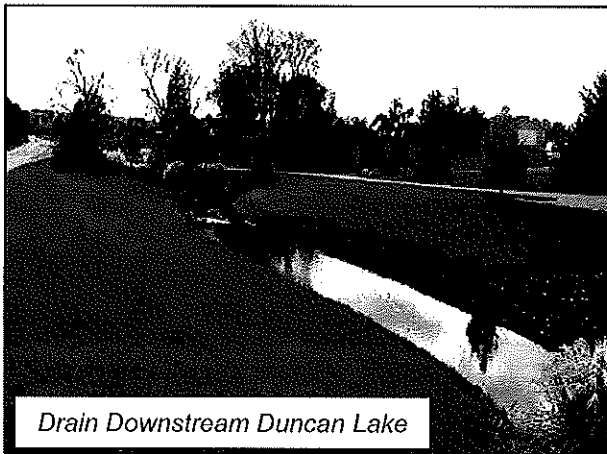
Drain Downstream Duncan Lake

The Noffke Drive culvert essentially acts as the water level control structure for Duncan Lake. The gradient of the Drain between Noffke Drive and Duncan Lake Road is approximately 0.1% and aside from some minor sediment buildup near Duncan Lake Road, the Drain is relatively clean and open.

Culvert Replacement: The culverts at Noffke Drive and Duncan Lake Road will need to be lowered and should be upsized to optimize the hydraulic capacity of the Drain. The recommended culvert size at Noffke Drive is 15' x 8' concrete box (or similar) and at Duncan Lake Road is 15' x 10' concrete box (or similar).

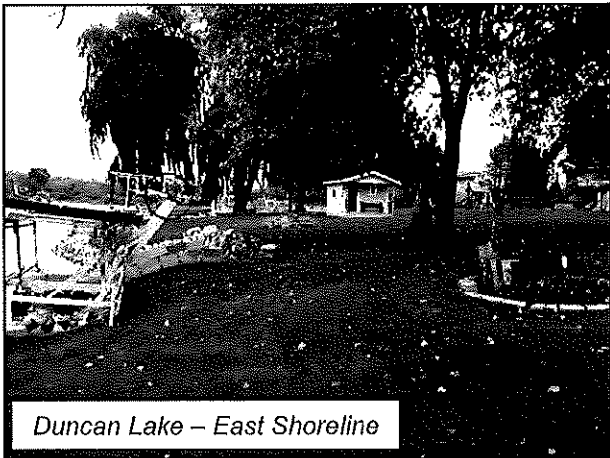
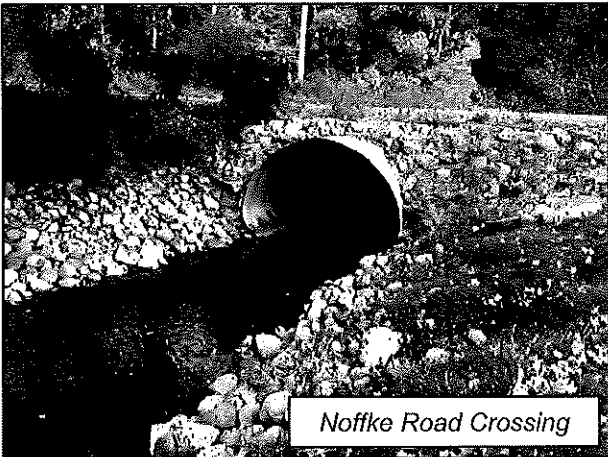
Duncan Lake – East Shoreline

The majority of homes around Duncan Lake are well above the 100-year floodplain. However, there are numerous docks, shore-stations, sheds and landscaping that are located within flood-prone areas. LRE recorded the minimum building opening (MBO) of the most low-lying residences along the east side of the lake (Noffke Drive), which are located above the EGLE 100-year floodplain but below LRE's estimate. Floodplain limits as well as critical survey elevations around Duncan Lake are provided in **Figure 1**.

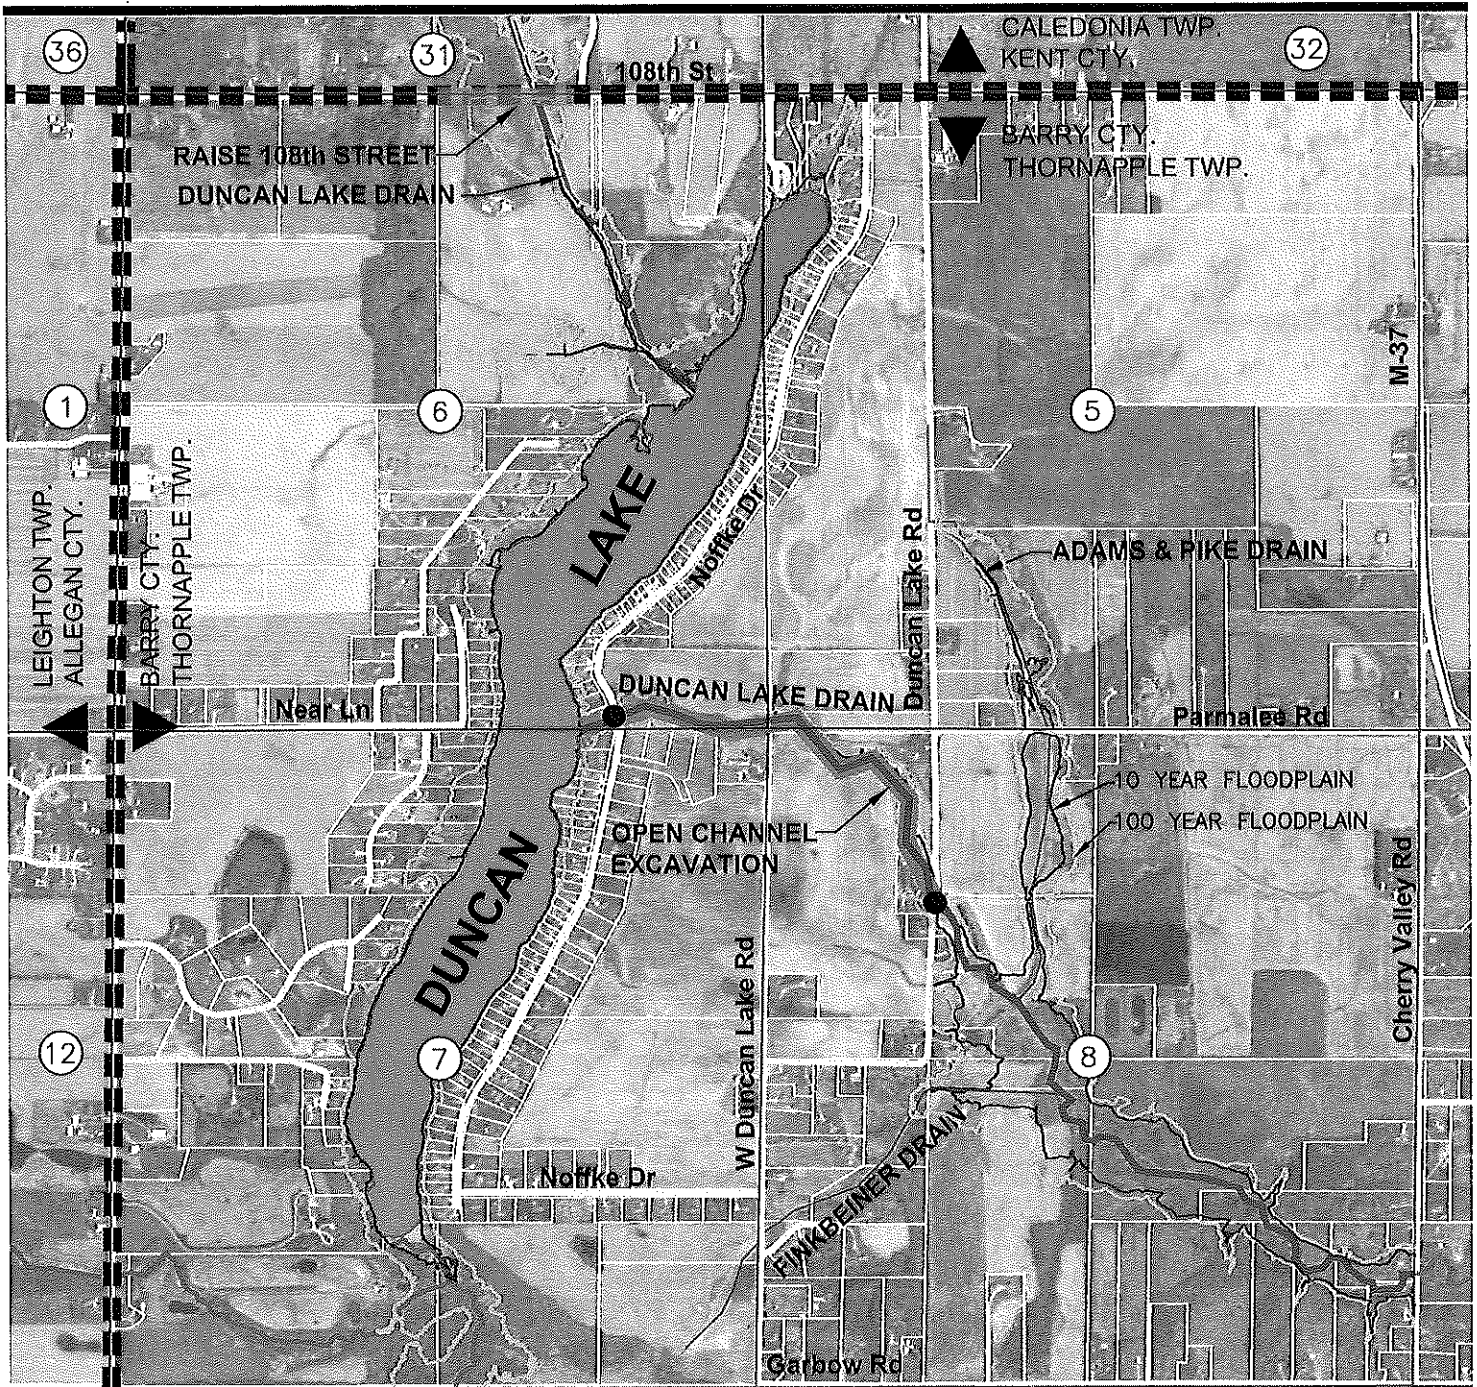
FIGURE 2

- **PROPOSED RAISE ROAD**
- **PROPOSED OPEN CHANNEL EXCAVATION**
- **DUNCAN LAKE ICD OPEN CHANNEL**
- **PROPOSED CULVERT REPLACEMENT**

the conveyance capacity of the crossing at 108th Street will be increased and the low-point in the road will be raised by more than 2-ft to provide a 100-year level of flood protection (point at which water overtops the roadway). A schematic map of the proposed maintenance and improvements associated with Alternative 1 is provided in **Figure 2**. Below is a summary of the major items of work.

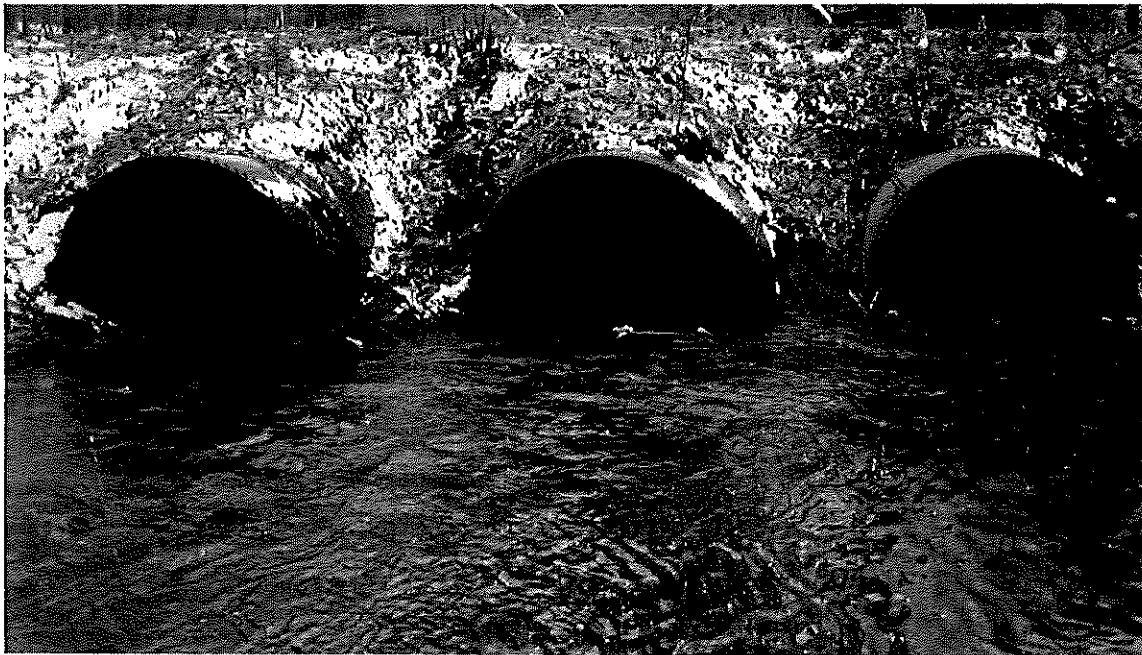
Picture No. 2 shows the upstream north end of the three steel culverts. The culvert on the far right of the picture (east culvert) has accumulated approximately 12 inches of sediment.

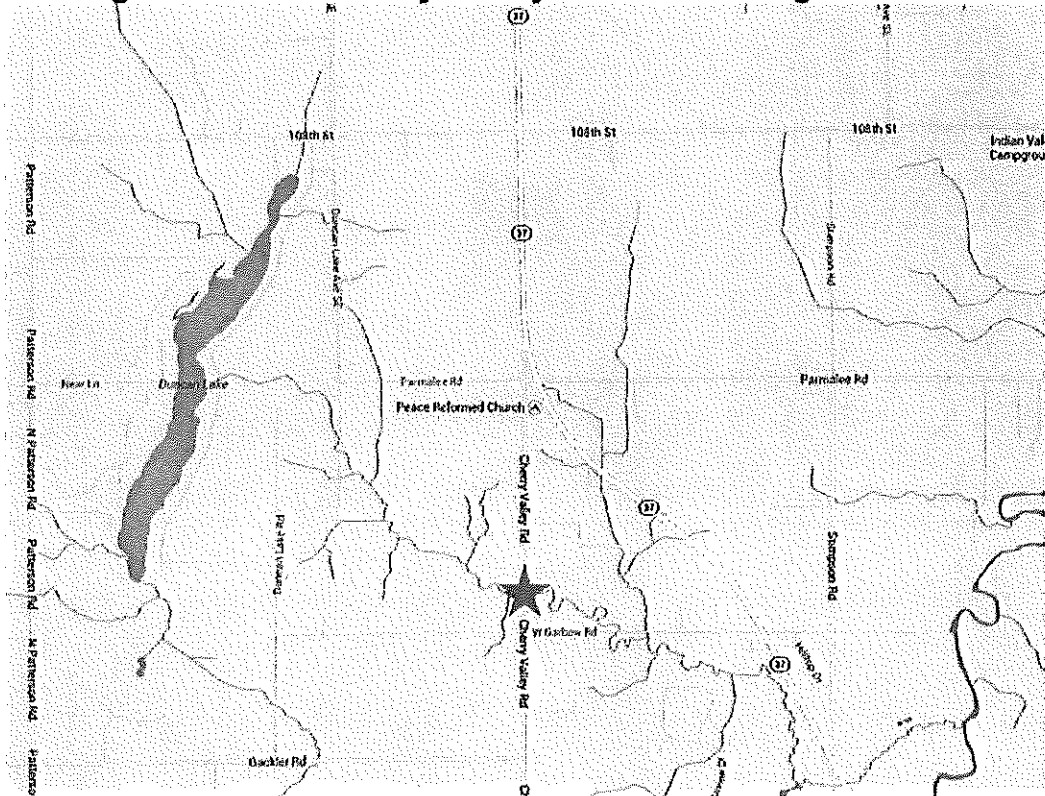
The Cherry Valley Road crossing is a 9-foot tall by 16-foot wide concrete box culvert in good condition. There were no noticeable signs of structural damage at the time of inspection.

Picture No. 3 shows the eastern downstream end of the 9-foot by 16-foot concrete bridge structure over Cherry Valley Road. Picture is looking towards the west.

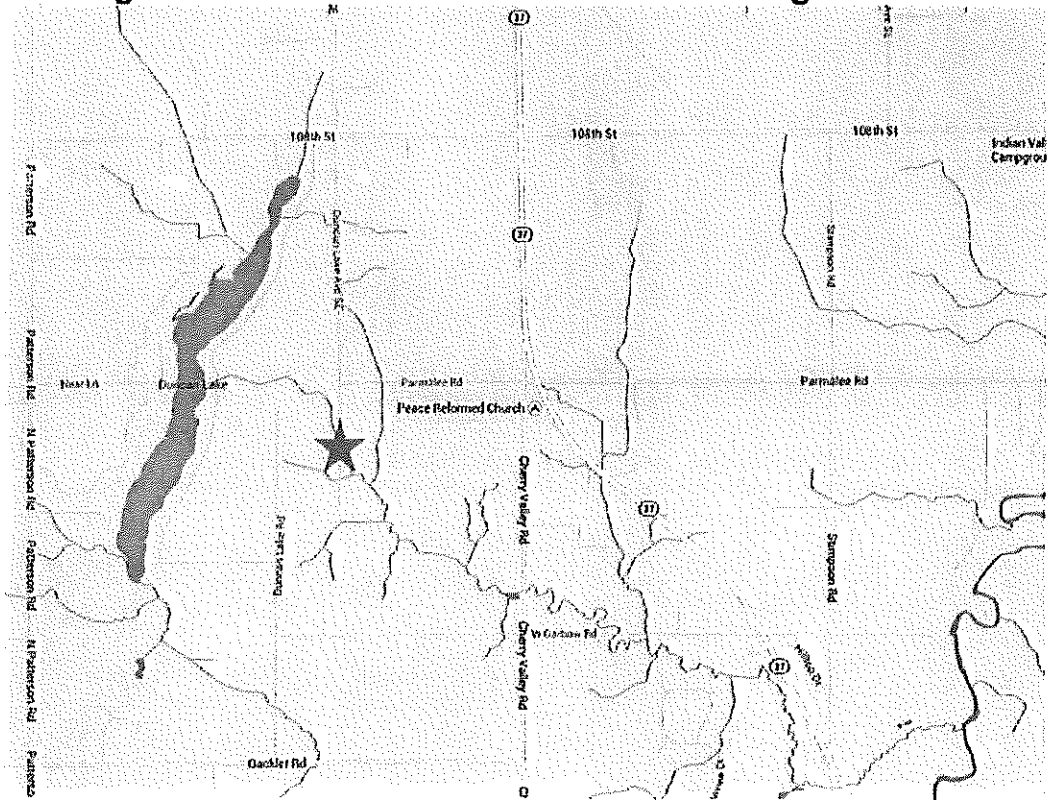
An 8-foot tall by 12-foot wide elliptical corrugated steel pipe (CSP) crosses under Duncan Lake Road. This culvert appeared slightly distorted due to possible settlement over time. Overall, it is in good condition with little to no sediment although there are signs of possible erosion near the downstream end.

Picture No. 5 is looking west at the downstream end of the 8-foot by 12-foot CSP culvert. Signs of erosion can be seen to the north of the outlet end.

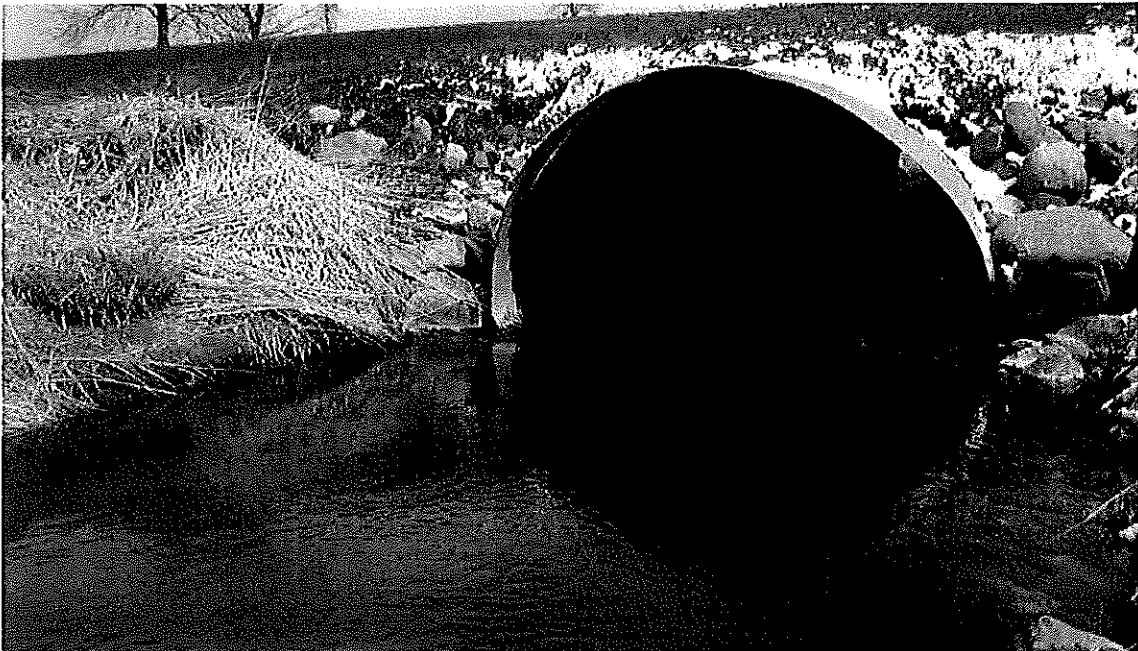
Picture No. 6 is looking east at the southern upstream end of the 8-foot by 12-foot CSP culvert under Duncan Lake Road.

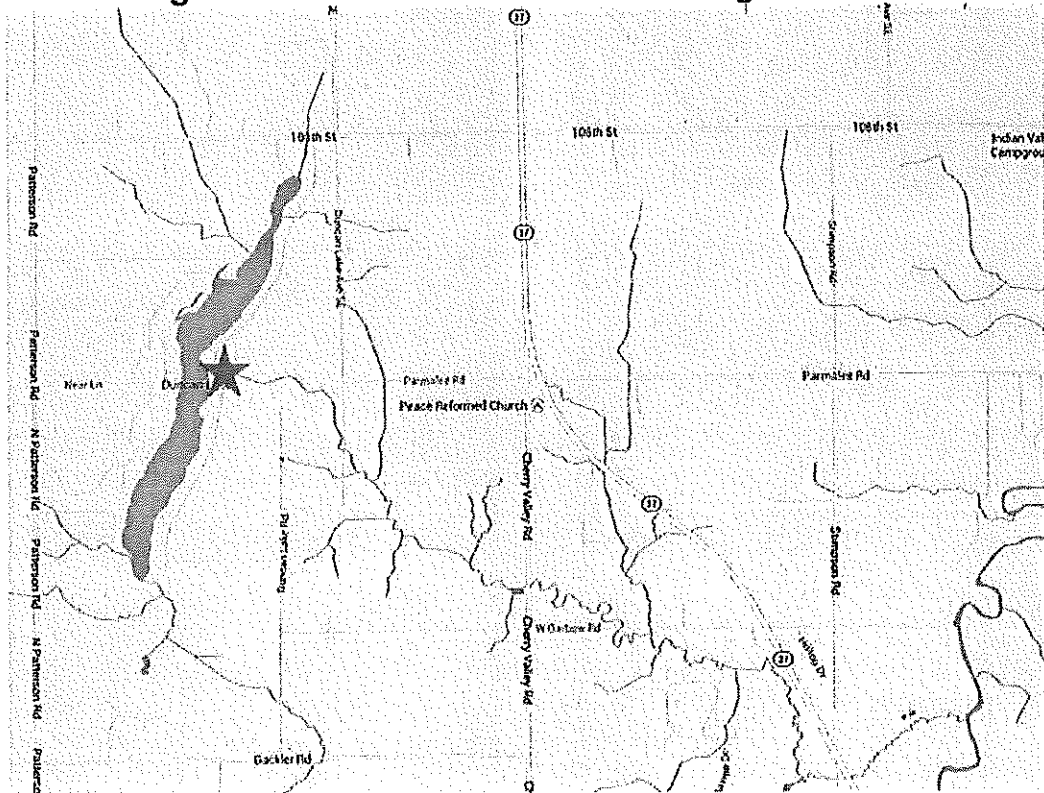
The Noffke Road crossing consists of a 7.5-foot tall by 11.5-foot wide elliptical CSP culvert. There is rusting below the waterline, approximately the bottom 1/5 of the pipe but no sediment was observed within the culvert.

Picture No. 7 is looking at the east downstream end of the 7.5-foot by 11.5-foot elliptical CSP culvert crossing under Noffke Road. Picture is taken looking towards the west.

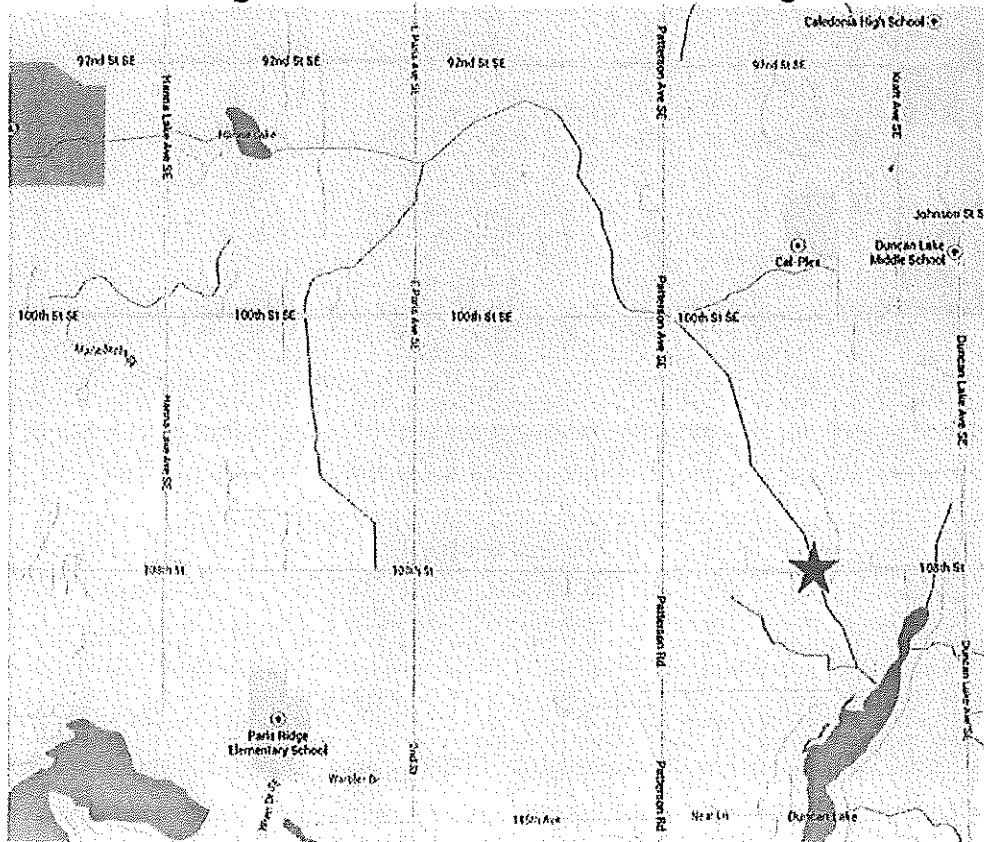
The 108th Street crossing is an 8.5-foot tall by 13-foot wide elliptical CSP culvert that is in good condition. At the time of inspection, approximately 8-inches of sediment were built up within the culvert.

Picture No. 9 shows the southern downstream end of the 8.5-foot by 13-foot arch CSP culvert crossing under 108th Street. Picture is taken looking northwesterly.

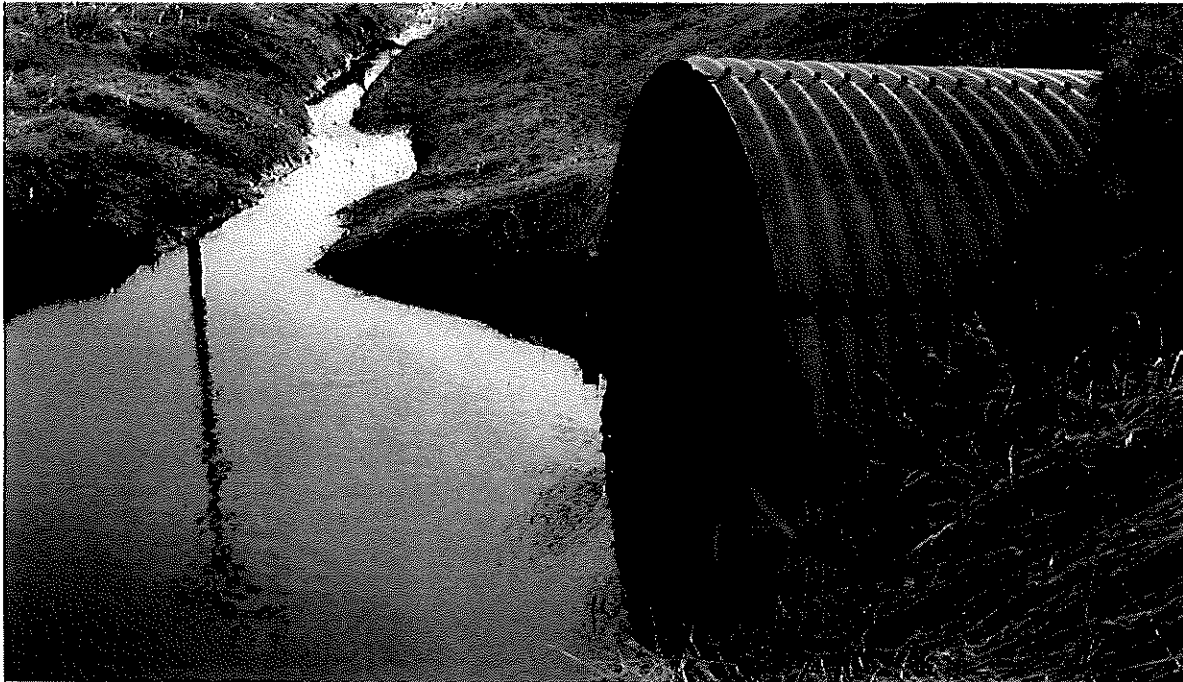
The 100th Street crossing consists of a 9-foot tall by 12.5-foot wide CSP culvert that is in good condition. There is approximately 12 inches of sediment build up within the culvert.

Picture No. 12 shows the upstream northern end of the 9-foot by 12.5-foot arch CSP culvert crossing under 100th Street.

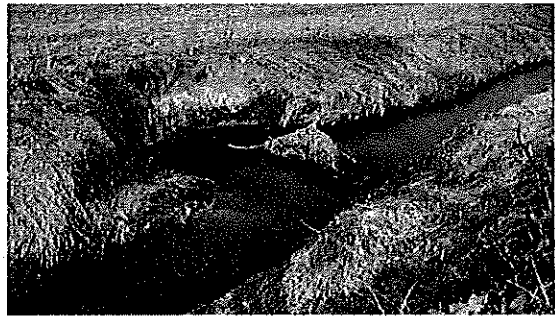
Figure No. 10 – East Paris Ave Crossing Location

East Paris Ave crossing consists of a 5-foot tall by 9-foot wide elliptical reinforced concrete pipe (RCP). This crossing is in good condition, although there is approximately 6 inches of built up sediment within the culvert.
