Allegan County Mental Health Services Building

Facility Assessment
2023

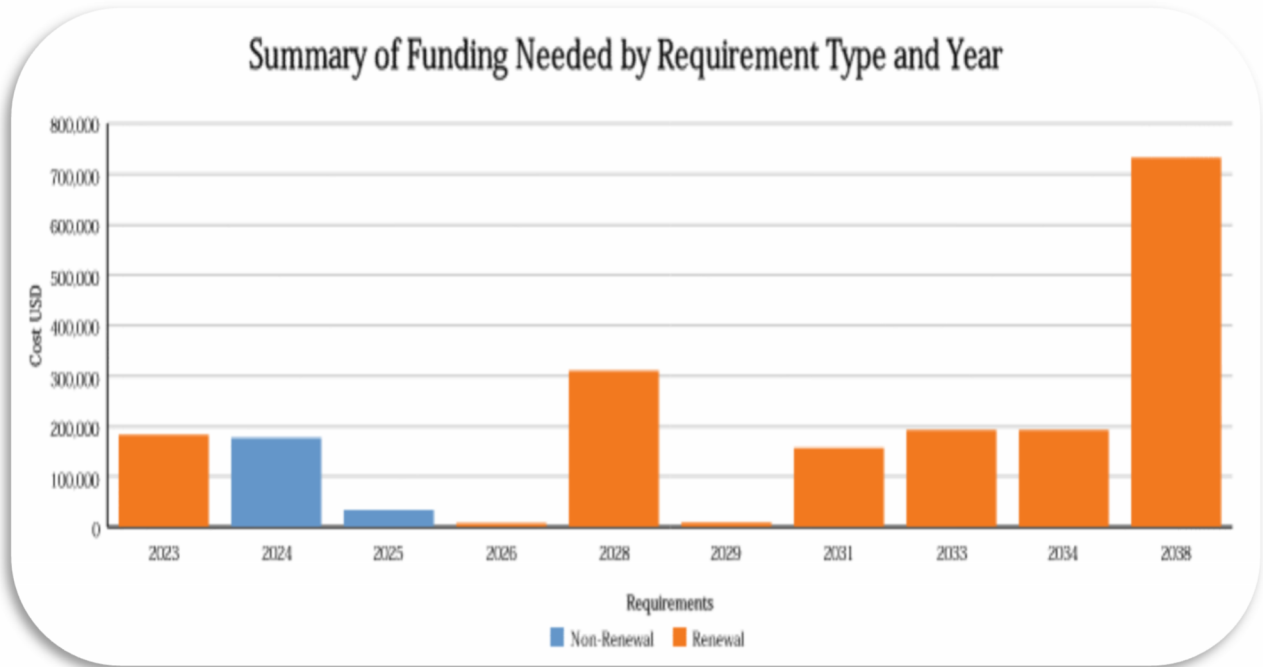
The facility assessment provides a list of required near-term actions and a look at potential future costs. The following graph shows years where significant investments may be needed. There is a very substantial requirement in 2038 as multiple systems reach the end of their useful life.
